CASE REPORT

Utilisation of plain film and theatre radiography in the diagnosis and treatment of neck of femur fracture in an elderly woman in Zambia

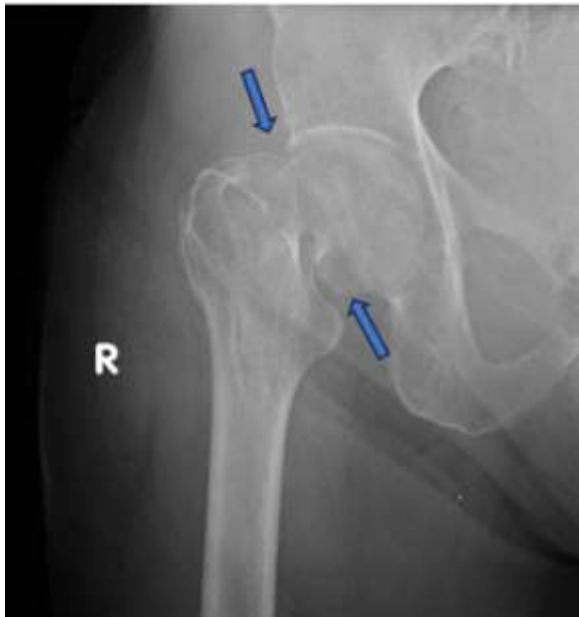
in a hospital gown. After preparing the computed radiography (CR) equipment and accessories, the procedure was explained to the patient, who was then carefully transferred to the X-ray table and positioned for the anteroposterior (AP) pelvis. The radiograph was acquired using exposure settings of 80 kilovoltage peak (kVp) and 30 milliampere-seconds (mAs). The imaging plate was processed using the CR reader, and the image was annotated and assessed for diagnostic quality before being sent to the referring casualty medical officer via Insta HMS. The patient was subsequently returned to the A&E department. The radiograph (Figure 1) revealed a fracture of the neck of the right femur, with a disrupted Shenton line.

Figure 1: AP radiograph showing a fracture of the neck of the right femur

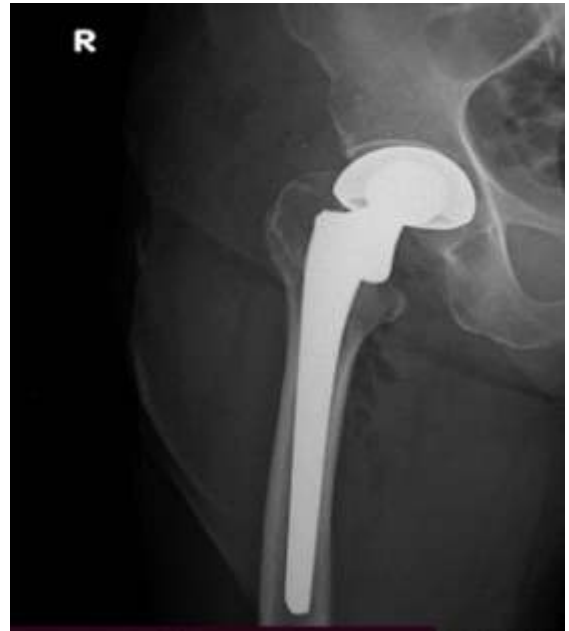
assess the positioning of the prosthetic implant. However, no theatre or fluoroscopic images were saved due to a malfunction in the C-arm's saving function. On the second post-operative day, a right hip X-ray was performed in the radiology department, which confirmed that the prosthetic implant was in a satisfactory position (Figure 2).

Figure 2: AP radiograph of the first post-operative right hip X-ray

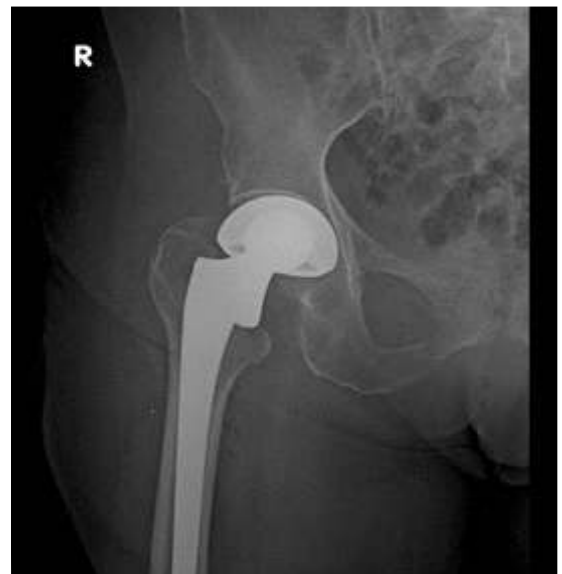
Figure 3: AP radiograph of the second post-operative right hip X-ray

A second post-operative X-ray of the right hip was performed on post-operative day four (Figure 3). The patient demonstrated good recovery and was discharged from the hospital on the eighth day of admission. She was scheduled to begin physiotherapy and advised to return for a follow-up appointment in three months.
